Post-Hurricane Laura Review: Impact on Existing CPRA Projects

CPRA Board Meeting

September 30, 2020

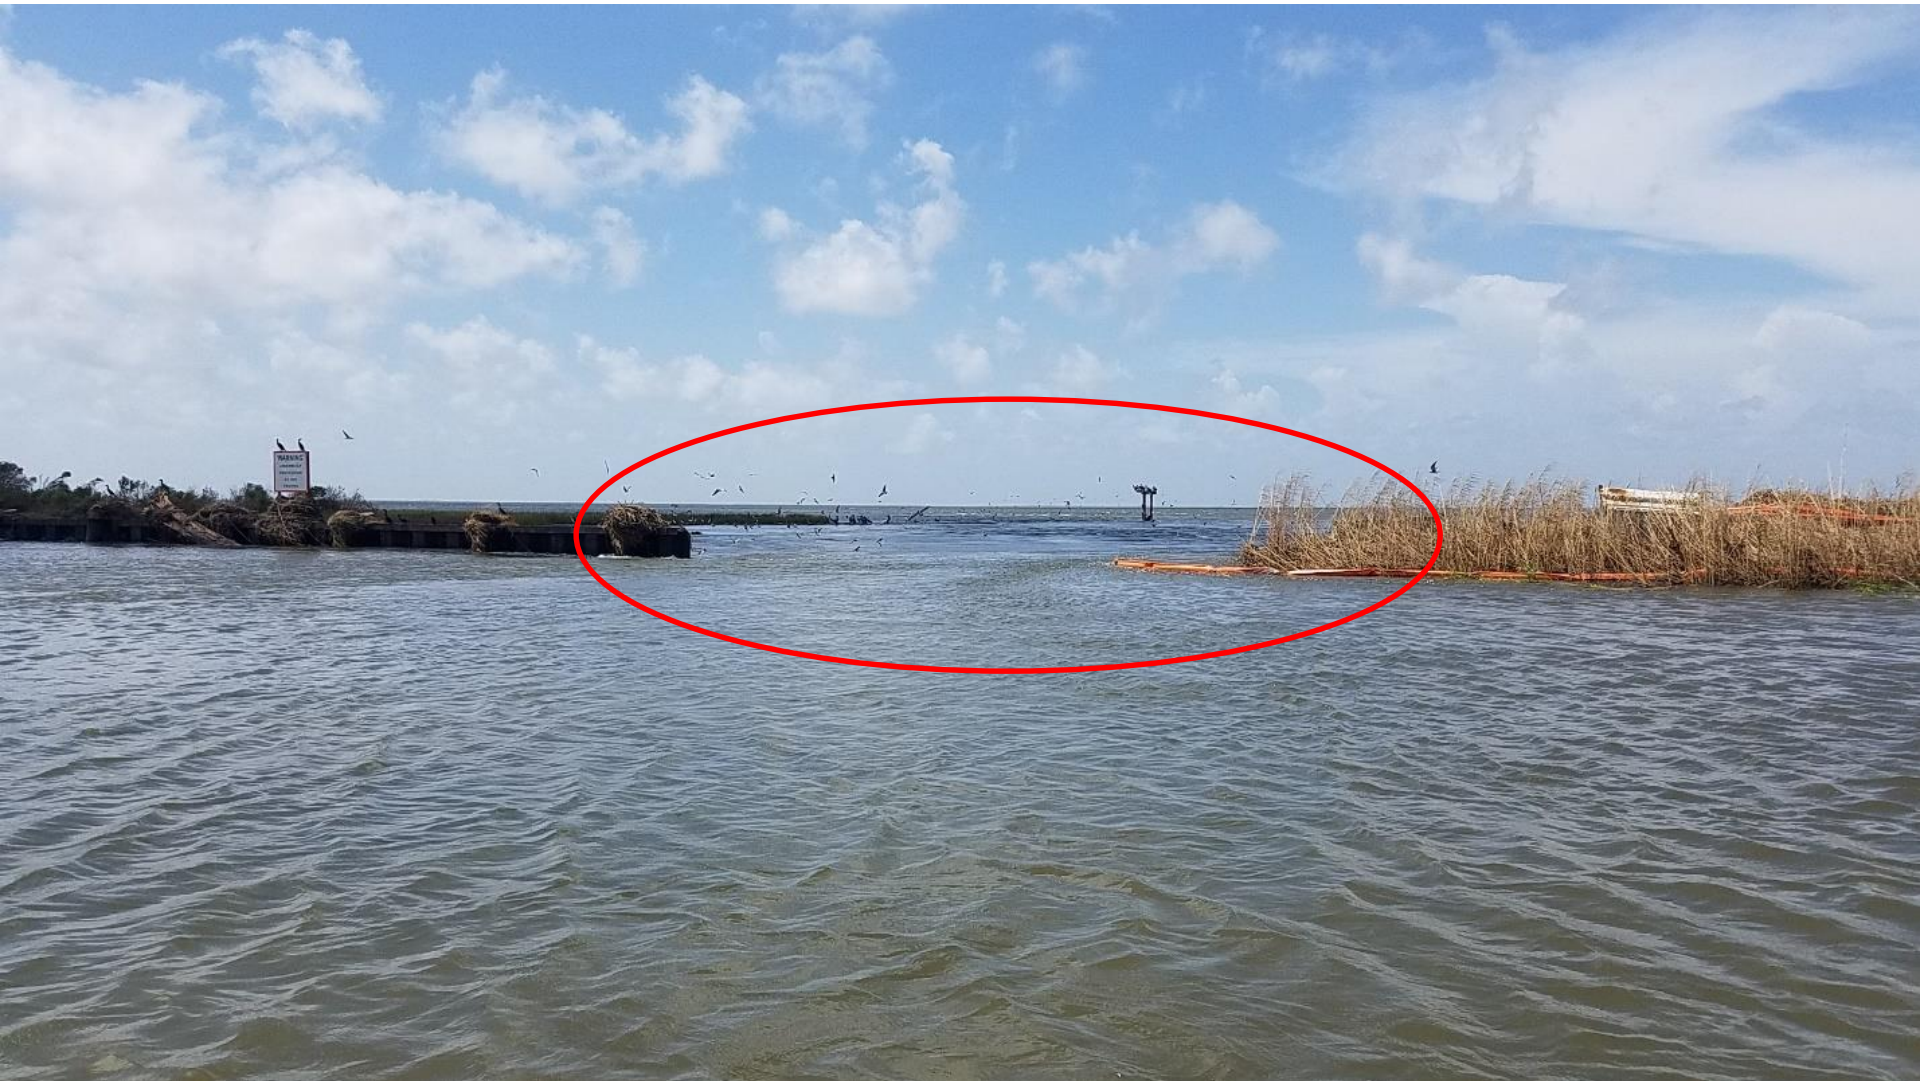
Breach at Sheetpile at Grand Bayou Structure

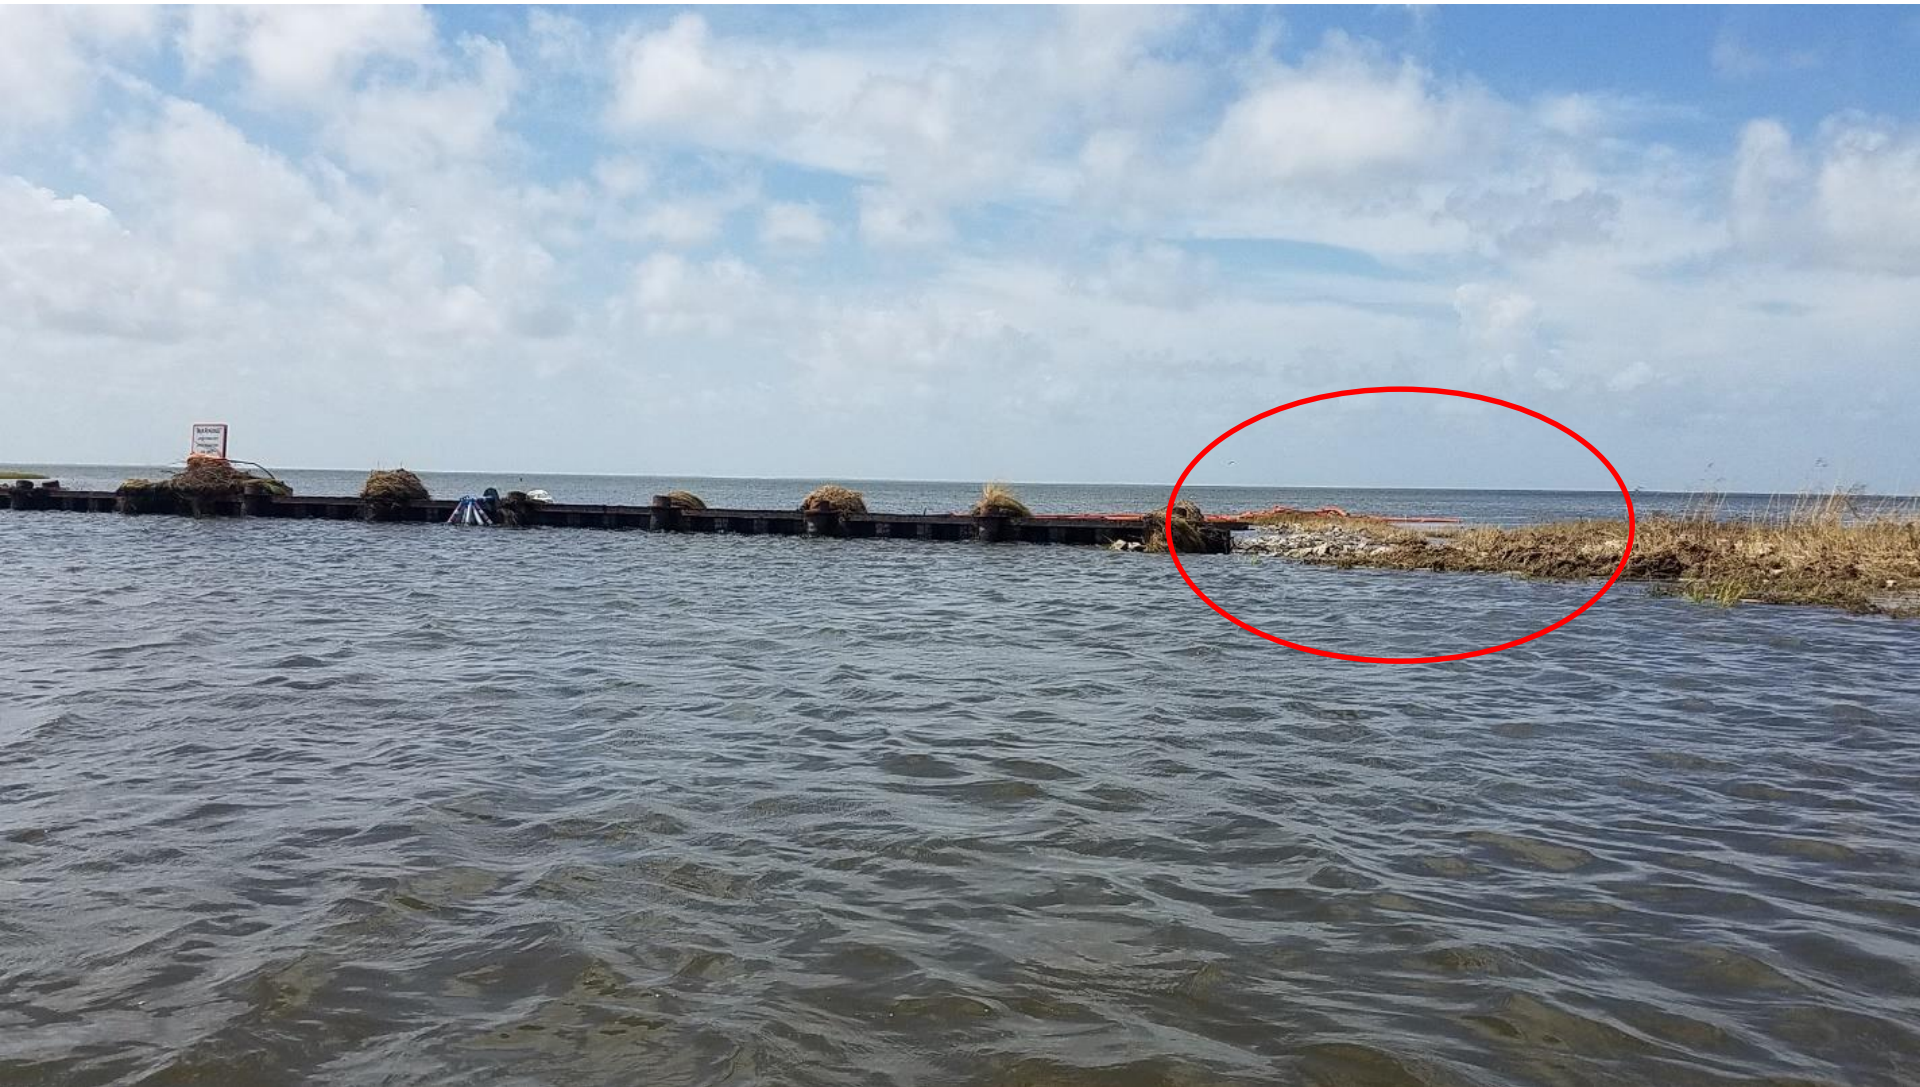
Breach at Sheetpile at Lambert Bayou Structure

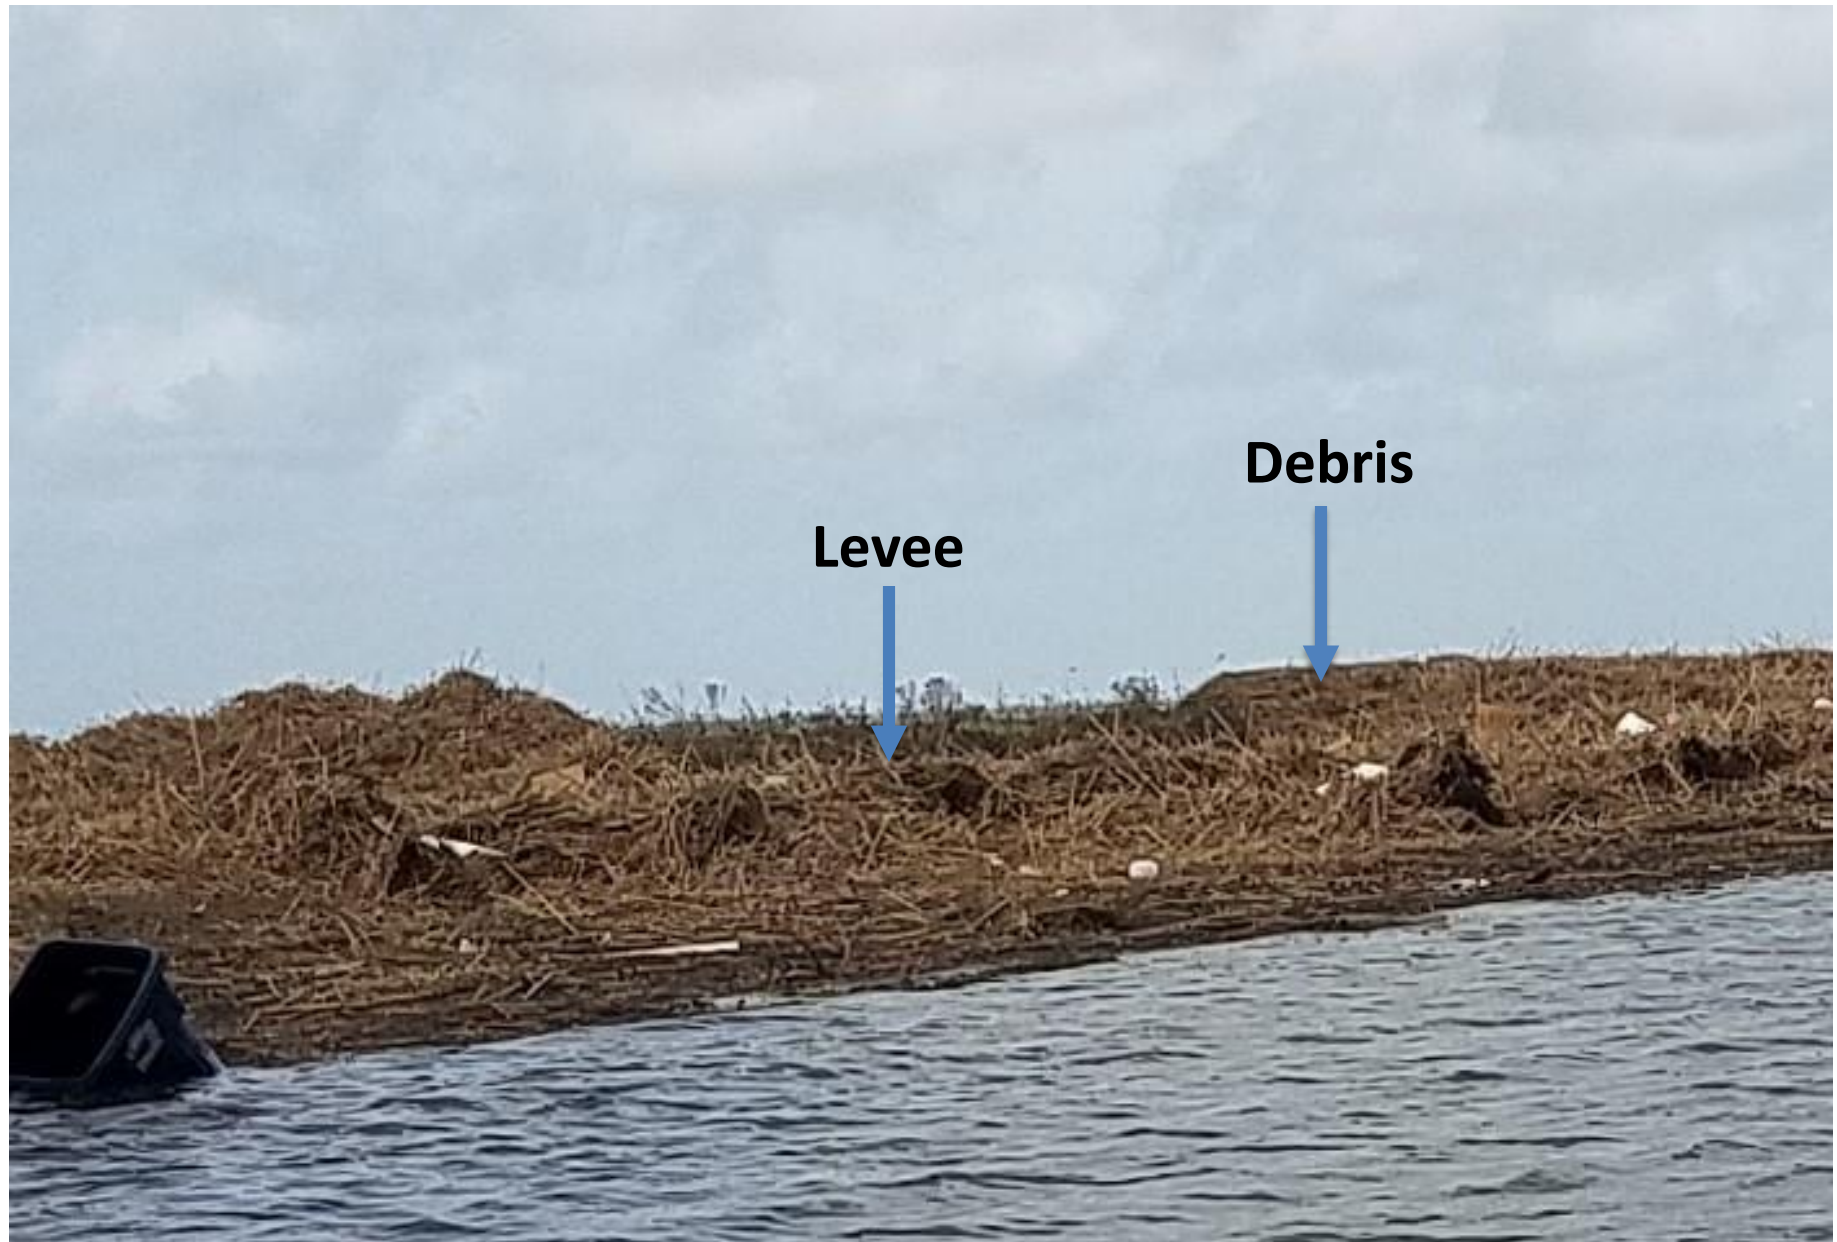
Vegetative Debris on Levee

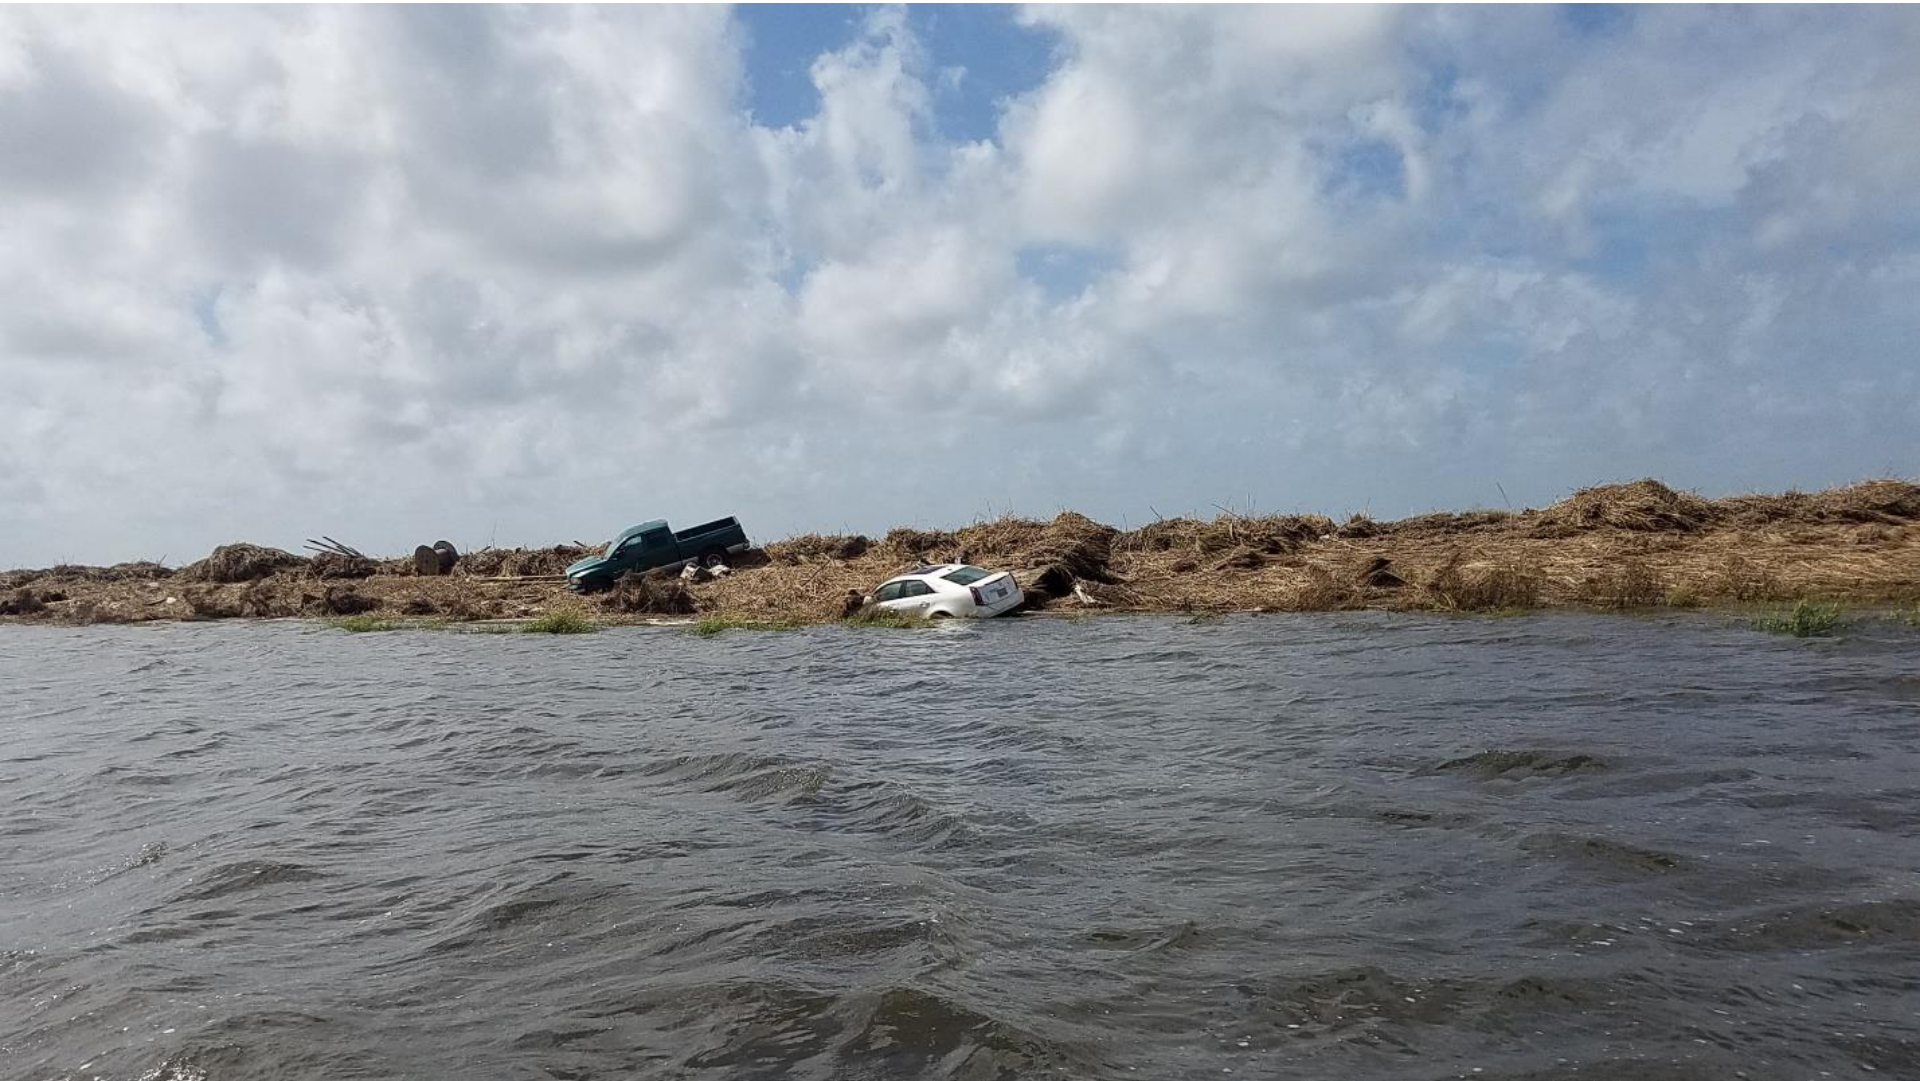
Misc. Debris on Levee

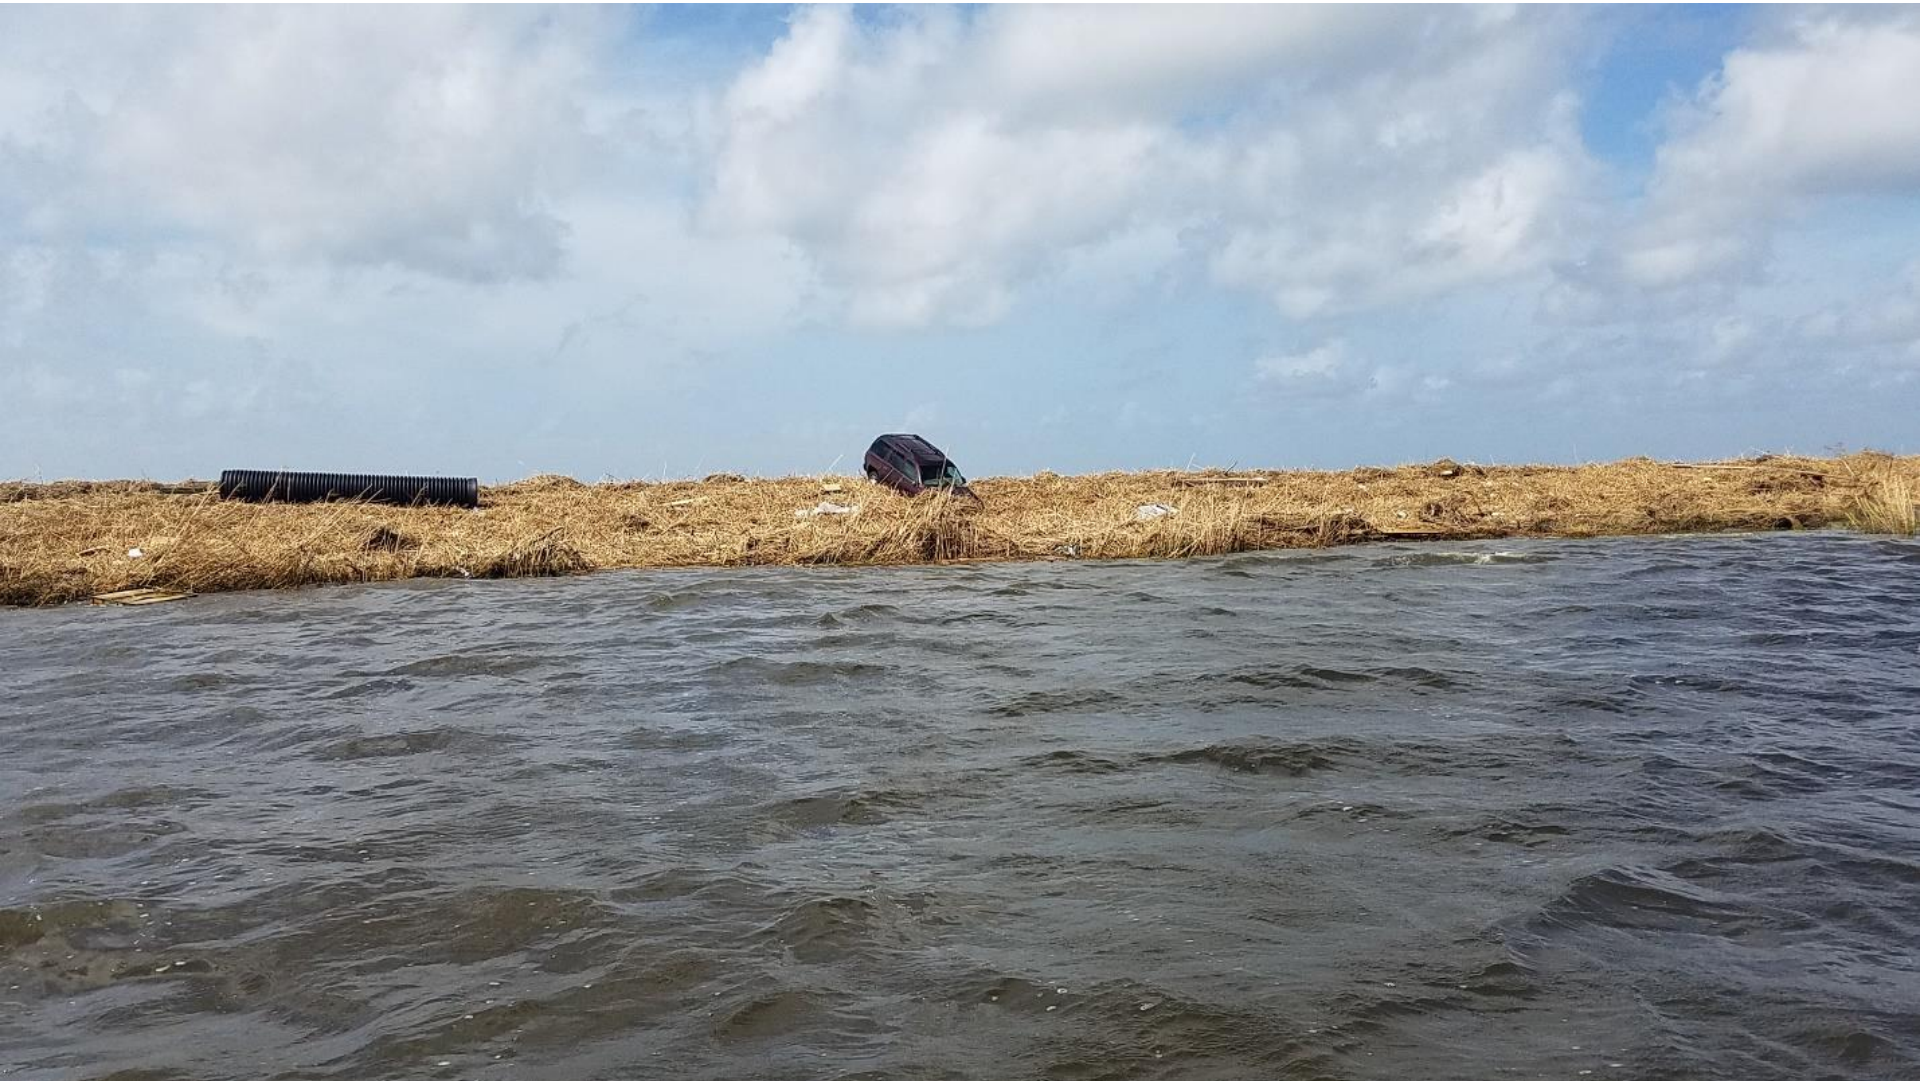
Misc. Debris on Levee

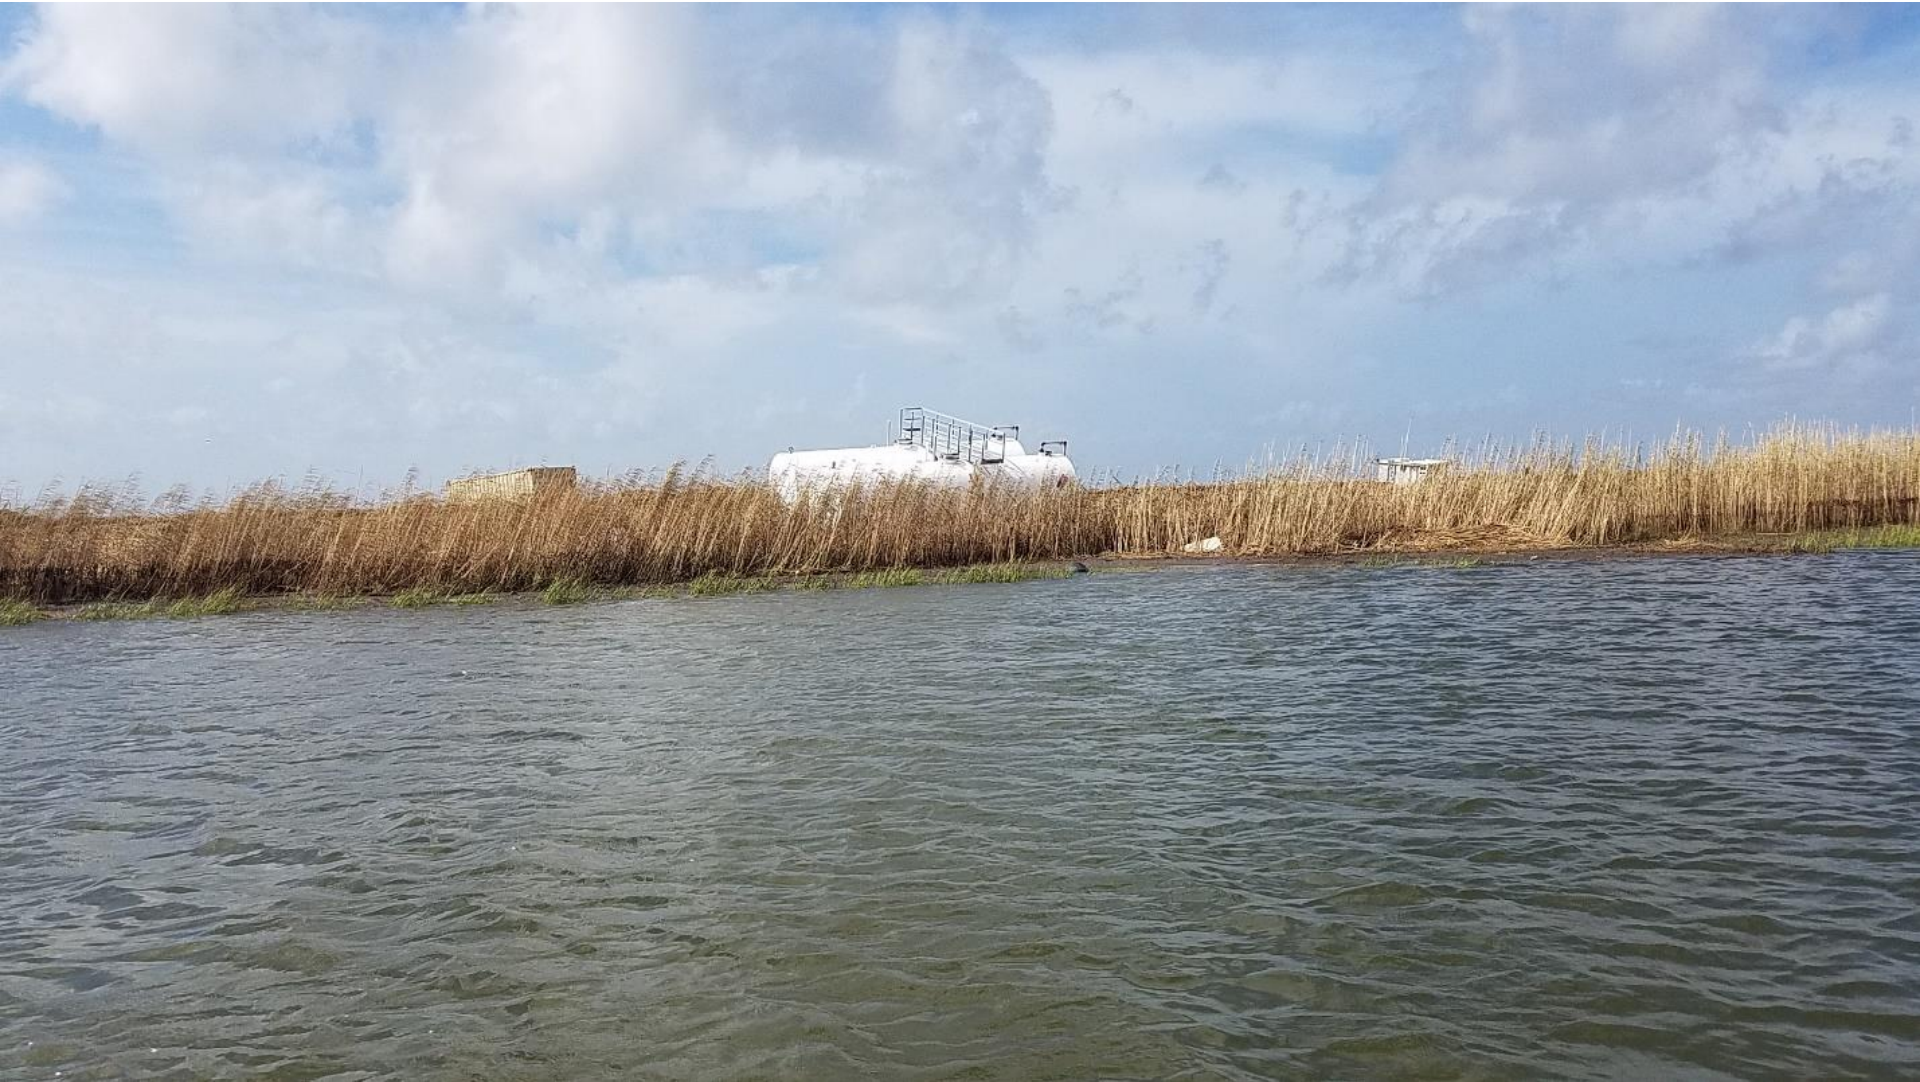
Misc. Debris on Levee
